TECHNICAL NOTE 2675

MEASUREMENTS OF FLYING QUALITIES OF AN F-47D-30 AIRPLANE  
TO DETERMINE LATERAL AND DIRECTIONAL STABILITY  
AND CONTROL CHARACTERISTICS

By R. Fabian Goranson and Christopher C. Kraft, Jr.

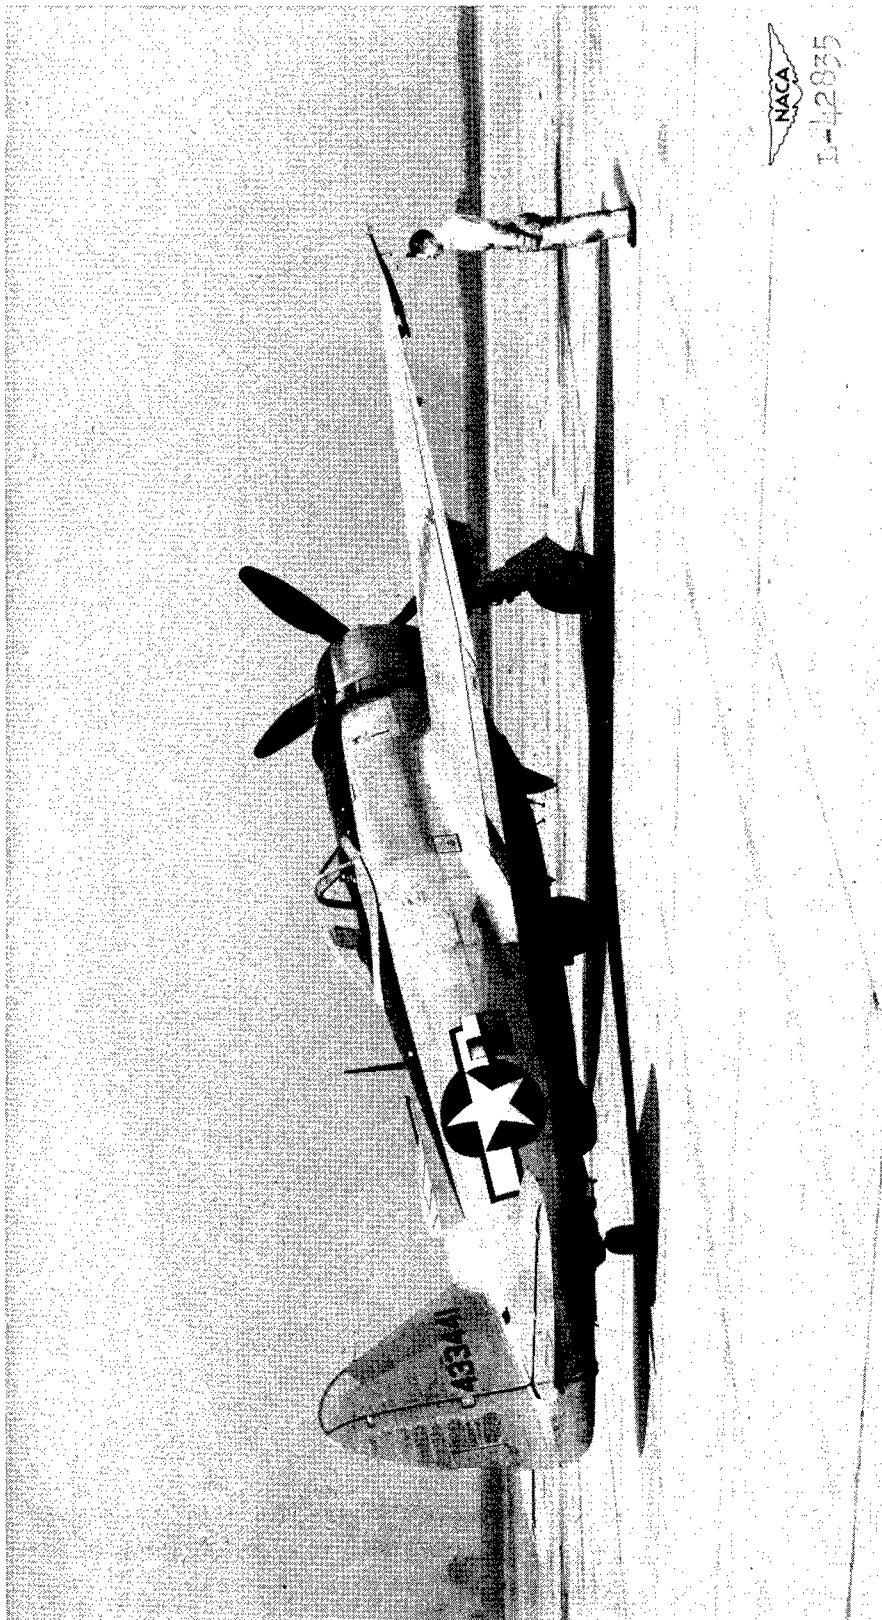
Figure 4.- Three-quarter rear view of F-47D-30 test airplane.
